The ESI Newsletter

Elastomer Specialties, Inc.

Volume 3, Issue 1, December 2003

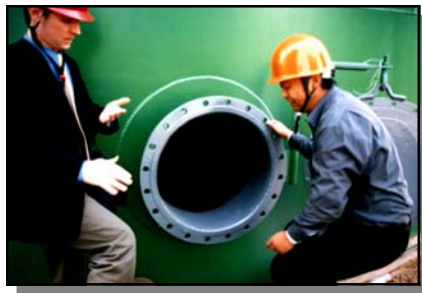
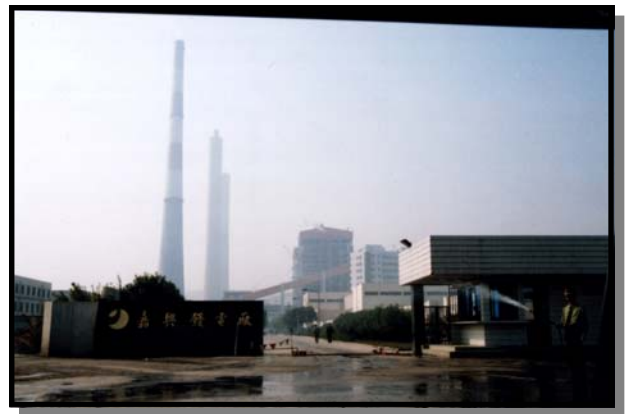
Jiaxing Power Plant South of Shanghai, China

NUKOTE/ESI's certified contractor and installer, Shanghai Langang Anticorrosion (SLA), has just completed a major polyurea installation at the Jiaxing Power Plant about an hour south of the city of Shanghai. SLA applicators, with NUKOTE/ESI technicians assisting, worked hard together to coat over 10,200 square meters of concrete including nine large tank interiors and ten large primary containment basins. **ElastoGard ARC** was the polyurea of choice due to its excellent physical properties and ability to perform well on concrete. SLA's success in closing this project, and other projects of similar size, is due to their tireless dedication to educating the end users, in their case, power production and distribution executives, the benefit of using high-quality, pure polyurea. A large part of this education process includes working with local and national design institutes to establish NUKOTE/ESI **ElastoGard ARC** as a national

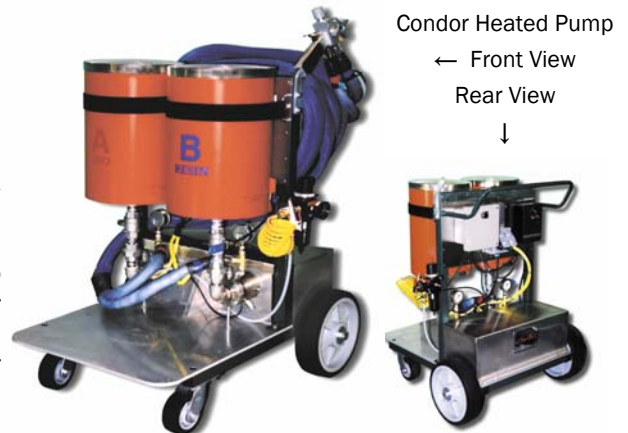
Developed specifically for low-pressure spraying, plural component Polyurea coatings at low temperatures, the latest model from Elastomer Specialties comes with heated & insulated lines and 7-gallon stainless steel tanks, which are designed to maintain a constant temperature range of 125° F to 150° F. Still light weight, this new model is available with either pneumatic or semi-pneumatic tires & hose lengths up to 75 feet. For additional information on the "New" Condor Extreme, visit our website at www.elastomer.com or give us a call at 1-800-786-4244.

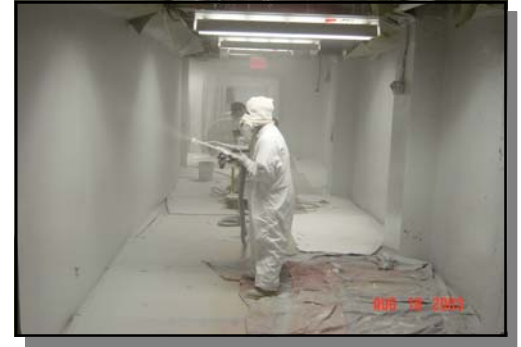
Application of PolySpar LP1

the polyurea over spay. Once this extraction tube was in place the APS crew was able to proceed with all the surface preparation. The primer used on the project was ESI's PoxyPrime H₂O, a water based epoxy primer with *NO ODOR*. According to Mario Colletti, the company's owner, the primer was sprayed onto the walls and floor areas with an airless sprayer and was ready for recoat in less than 1 hour. The customer, Costagna Realty, who manages the complex was impressed with how fast the application of the coating system was done. Using a Condor

Deluxe Pump by ESI, the aromatic floor coating, ElastoGard ARC and the colorfast polyaspartic wall coating, PolySpar LP-1 was installed, 4 days ahead of schedule. Once completed the management company praised ASP for the excellent job and materials used.

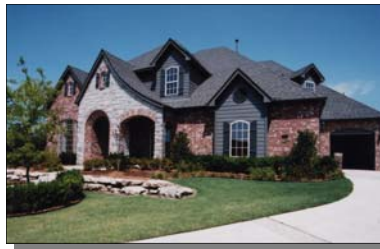
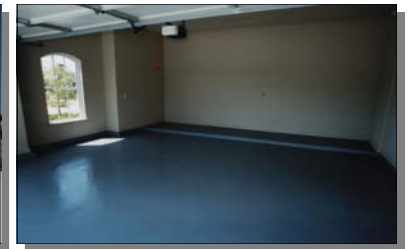
\$550,000.00 home, located Southeast of Tulsa, was amazed at how simple the system was to install. Design Mark Builders' 2-man crew pressure washed the entire 650 SF of garage floor area, installed ESI's Poxylite H2O primer (225 S.F. per gallon) and applied two coats of EcoSpar, Medium Gray in less than 5 hours. Extremely tough,

durable, easy to install and repair, the New EcoSpar concrete protective coating system is ideal for the rapid growing housing industry, says Bob Hancock, the owner of Design Mark Builders.

Elastomer Specialties' rapid curing roll down polyaspartic coating, EcoSpar, has found a new niche market in the upper end housing industry for sealing and coating garage floors. Unlike current epoxy floor systems which take time to install and even longer to cure, EcoSpar is unique in the sense that once the surface has been properly prepared, primed and coated it can be opened to both foot and vehicle traffic within just 90 minutes. The general building contractor that specified the "New EcoSpar" system on this

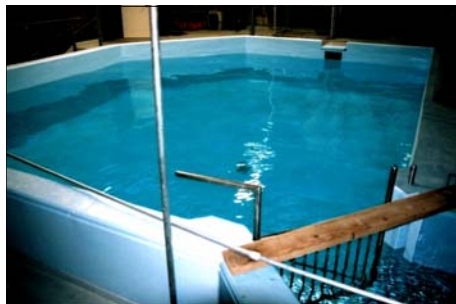
Finished picture of the medicine treatment tank at the OKC Zoo.

The Oklahoma City Zoo recently contracted Evans Industrial Coatings Co. of Russellville, AR to renovate the medicine treatment tank at their aquatic center. The existing epoxy coating which was installed only 3 years prior had begun to develop serious surface cracks. Because this tank was used to treat sick sea mammals, the Zoo's maintenance director determined the tank to be unsafe and contacted several manufacturers to find a permanent coating solution. After several weeks of meetings Elastomer Specialties

was finally chosen to provide the coating system to repair the 1800 S.F. tank. The installation specification called for sand blasting in order to remove the failed epoxy coating then according to the ESI specification, AnvilDeck primer was installed, followed by ElastoGard ARC, a pure aromatic polyurea and top coated with PolySpar HP, a color stable polyaspartic. From start to finish the project took only 4 days to complete. The success of this application has inspired the Zoo's maintenance director to move ahead with additional tank and standard repairs for the 2004 season.

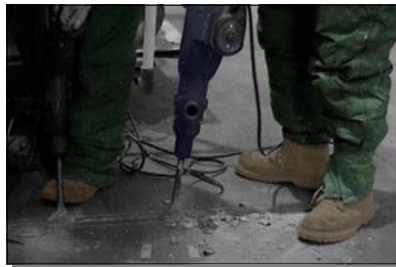
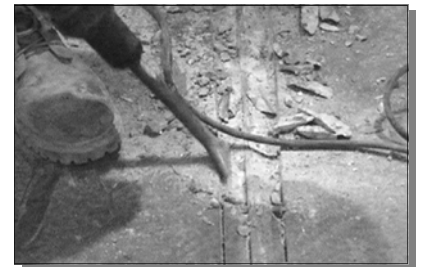
Above pictures: Concrete surface prep in -26°F temperature.

Merchants Distributing, Inc., located in Hickory, North Carolina had serious problems with damaged concrete joints, doorway thresholds, and spalls, and was in dire straits for a rapid solution to the problem. After several weeks of product evaluation and numerous phone calls by the maintenance department, two manufacturers were contacted, with great aspirations of a quick remedy. The maintenance department stipulated that each product manufacturer had to send in a certified installer, in order to demonstrate the worth of their system. Only Elastomer Specialties ES-2350 Sub-Zero floor repair polyurea passed the test. The certified contractor for ESI, Golden Floor Preparation out of Golden, Colorado, specializes in freezer and chiller floor repairs on a Nation Wide basis. They put on an excellent installation demonstration for the facility owner and was awarded the contract. Completed, the project took a 4-man crew approximately 3 weeks. Included in the job profile was 2,000 lf of freezer floor repairs, at constant temperatures of -18°F to -26°F and 3,000 lf of chiller area that averaged 35°F to 45°F. According to Rick Harris, the company's founder and owner, working 10 to 12 hour shifts in the sub-zero temperatures proved to be quite challenging in both keeping the equipment operational as well as coordinating & maintaining a tight schedule for the owner. With over

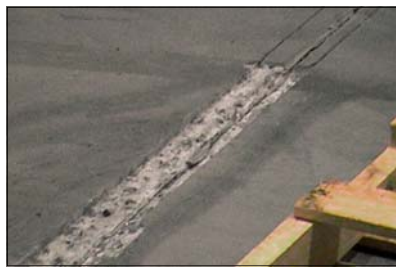
Picture of joint after it has been prepped

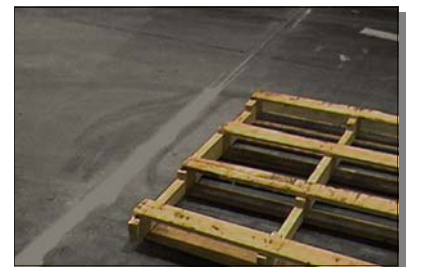
Picture after installation of ES-2350 polyurea
