Polyurea... Hydrogen Sulfide Resistant Industrial Sewage & Wastewater Coating for Rehabilitation of Concrete

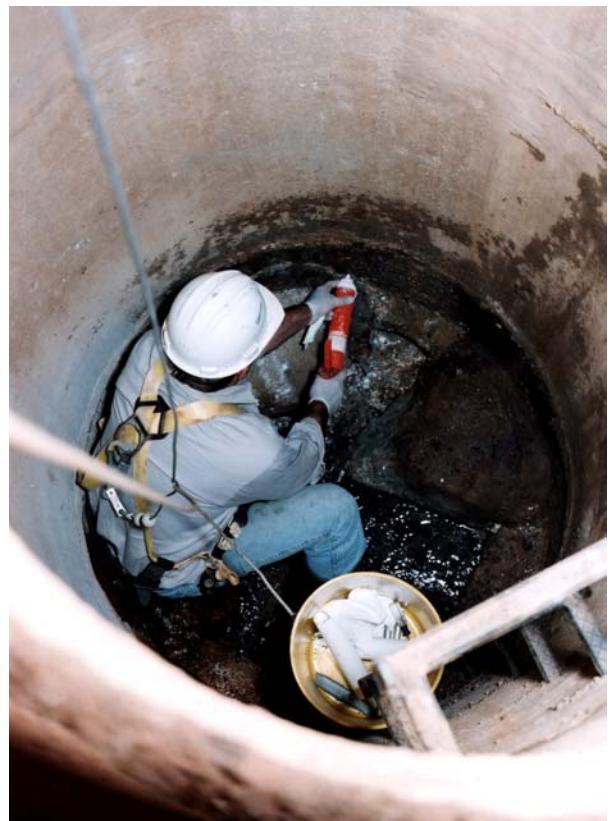
Mike Kronz of Remote Orbital Installations Preparing a Manhole for a Polyurea Lining

There are probably hundreds of sewage treatment plants under construction today that are not utilizing the benefits of polyurea coatings. However, it is becoming more and more commonplace for engineers to specify polyurea coatings as a corrosion control coating for new construction applications. This specification is becoming so popular that one contractor has even invented a robotic polyurea application system for manholes and sewage pipe¹. This robotic system can be used in the concrete pre-cast yard (after proper curing of the concrete) or in the field on previously placed manholes to apply a seamless polyurea lining that is essentially pinhole free in a matter of minutes.
